The following notes and diagrams are extracts from a Technical report issued by Grendon Design Agency Report. The original report recorded the performance of Pilkington Planar under Blast load conditions, as witnessed at the Comblast trials in May 2002. For security purposes, Pilkington have withheld specific information relating to the size of the explosive charge, the dynamic forces which that charge induced and the exact specification of the glass panels under test.

This test report records the results of explosion range testing conducted on Pilkington Architectural products as part of the Home Office sponsored Comblast 2002 Explosion Range Trials.

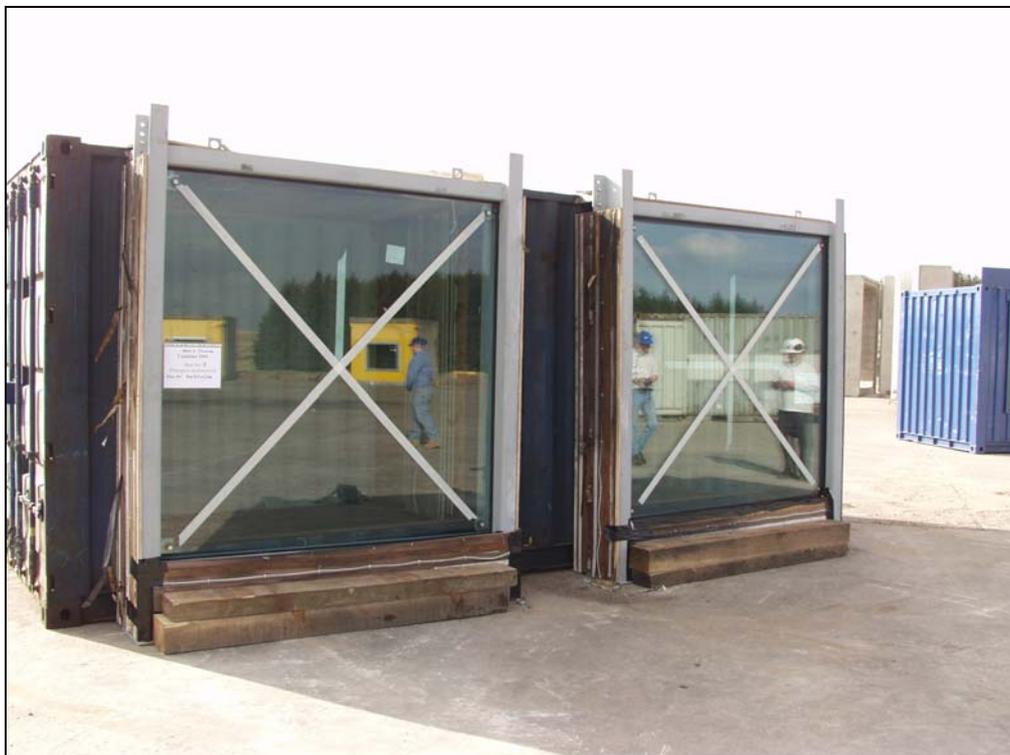
P1: View of test structure prior to first detonation.

The timber beams and side sheeting were added to prevent pressure leakage behind the test specimens into the interior of the test chamber. The timber elements needed to remain in place long enough for the shock wave to decay [approx 12 milliseconds] and dislodgement of the timber was not deemed to invalidate any of the results.

The individual test specimens are numbered as follows:

1L-1 = left hand specimen

1R-1 = right hand specimen

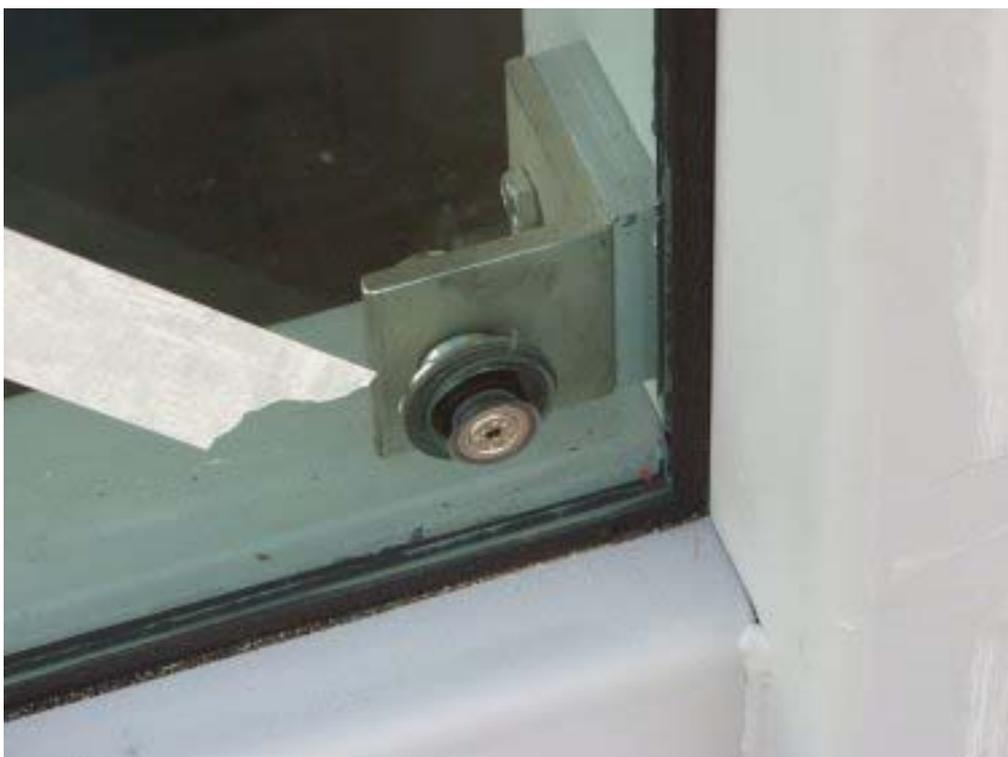
P2: Planar Bolt Support.

All four of the test specimens were mounted into a steel carrier frame and secured in place by a total of 4 Planar bolted connections. The above photograph shows the exterior of test specimen 1L-1. Note the structural sealant gasket connecting the glass to the steel carrier. The initial test was conducted with the structural silicone intact and subsequent tests were performed without the benefit of the sealant to ensure that tests replicated unsealed bolted glazing solutions.

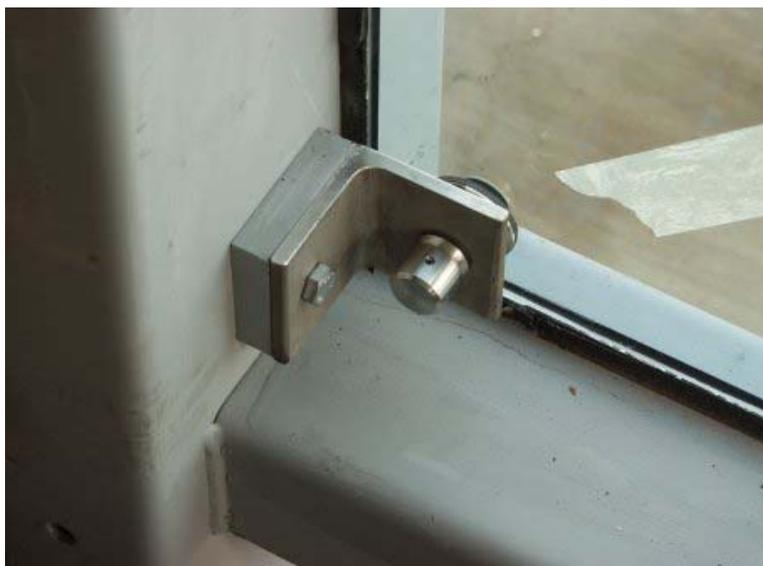
P3: Internal support detail.

Details of assembly of bolted glass support point are included in the annex of this report.

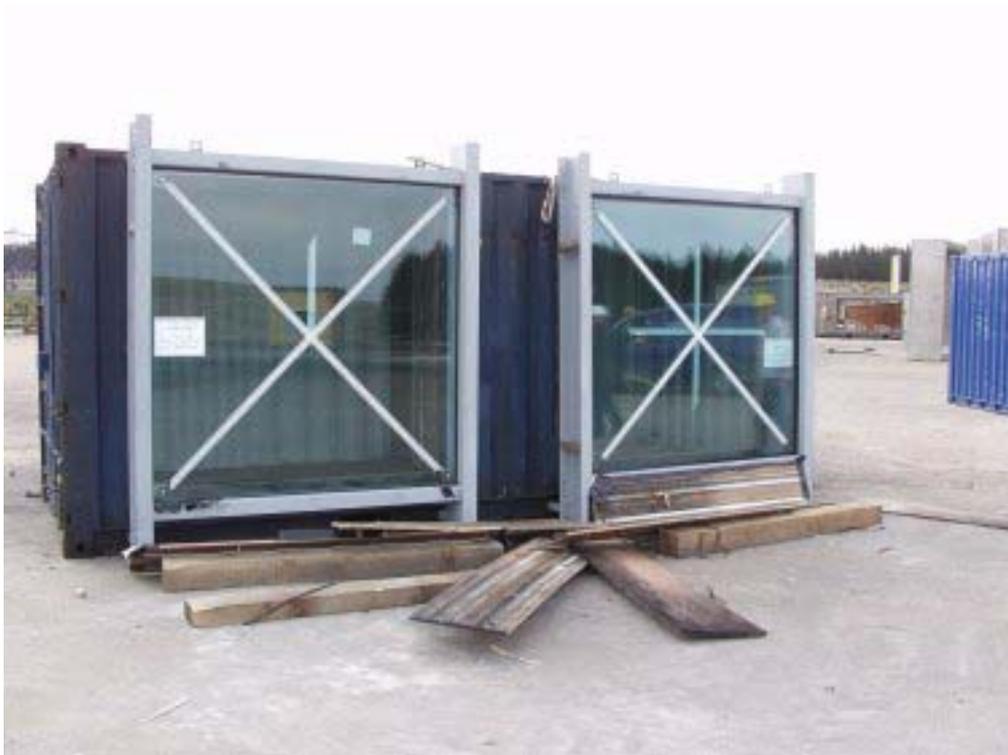
P4: View of test specimens post detonation.

Timber cladding torn off by blast wave. Both Planar test specimens appeared to be undamaged and the same samples were re-tested in test No 2 with the edge gasket cut through to simulate unsupported Planar glazing.

RESULT: The Pilkington test specimen 1L-1 achieved a UK Break Safe and US GSA Class 1 [undamaged] rating against ***kg TNT detonation at 25 metres.

RESULT: The Pilkington test specimen 1R-1 achieved a UK Break Safe and US GSA Class 1 [undamaged] rating against ***kg TNT detonation at 25 metres.

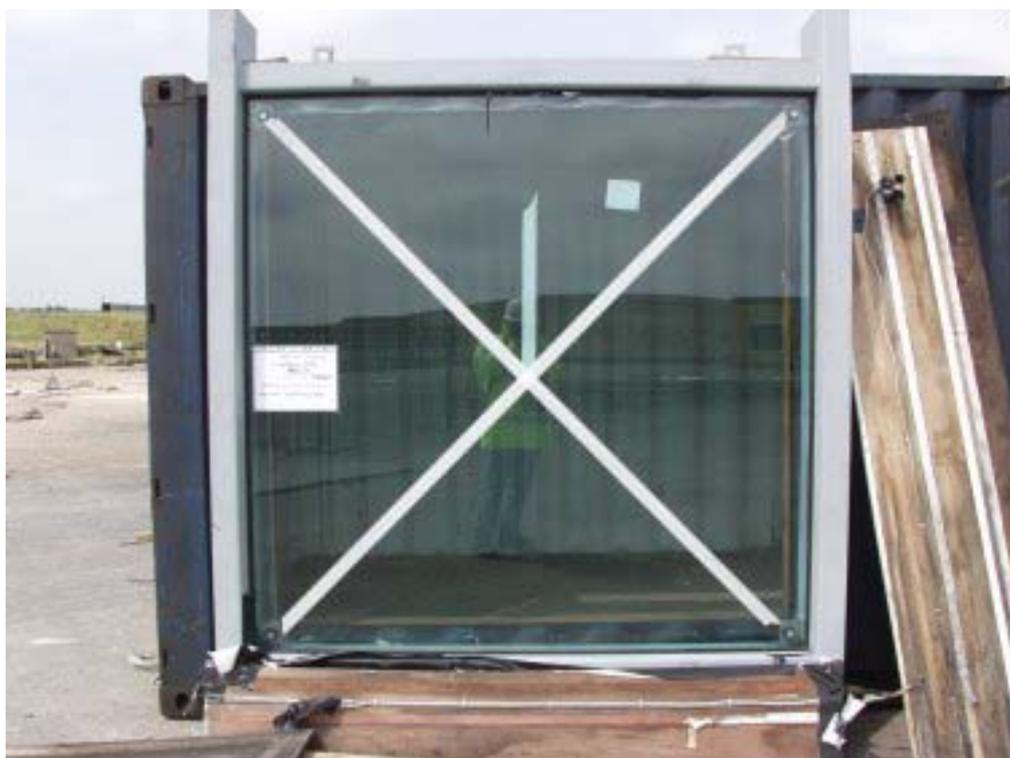
P5: Results Of Re-Test On Specimens 1L-1.

RESULT: Pilkington test specimen 1L-1 achieved a UK Break Safe and US GSA Class 1 [undamaged] rating against ***kg TNT detonation at 25 metres.

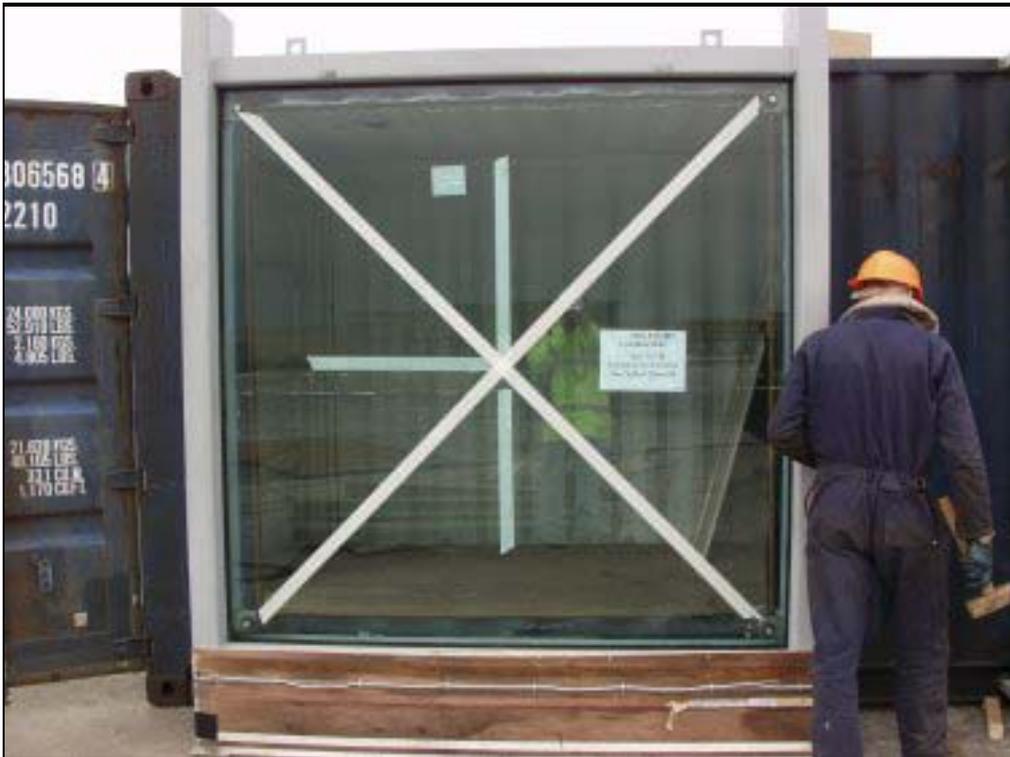
P7: Test specimen 2L-1.

RESULT: Pilkington Planar test specimens 2L-1 achieved a UK Break Safe and US GSA Class 1 [undamaged] rating against ***kg TNT detonation at 16.75 metres.

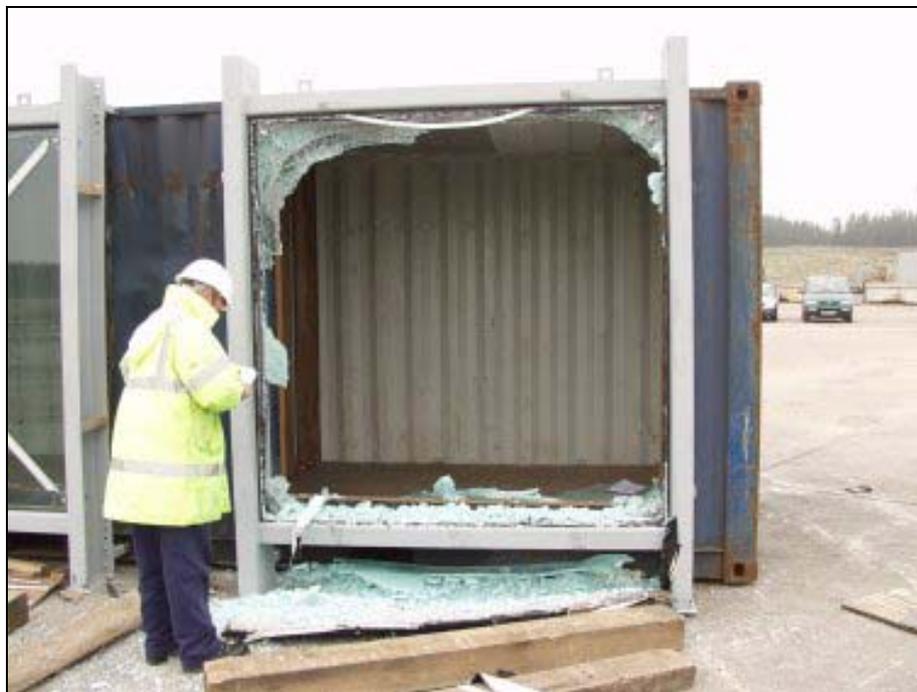
P11: Test specimen 2R-1 post detonation of *kg TNT @ 16.75m.**

The outer toughened glass shattered and fell to the ground below the test frame with approximately 10% of the glass found more than 1 metre to the front of the cubicle.

Test specimen 2R-1 containing insulated glass unit [49mm IGU] was mounted in a steel carrier frame and the silicone seal around the boundary of the glass was cut through to allow free movement of the glass independent of the test structure.

RESULT: Pilkington Planar test specimens 2L-1 achieved a UK Low Hazard and US GSA Class 3A rating against *kg TNT detonation at 16.75 metres.**
